Influence of Subsurface Details on
Braced Excavations in Puerto Rico
Alan R. Crumley, F. ASCE ¹

This is a condensed version of a paper presented at the ASCE National Convention in October, 1998 at Boston.

Case History I - A Deep Excavation Affected by Blowup

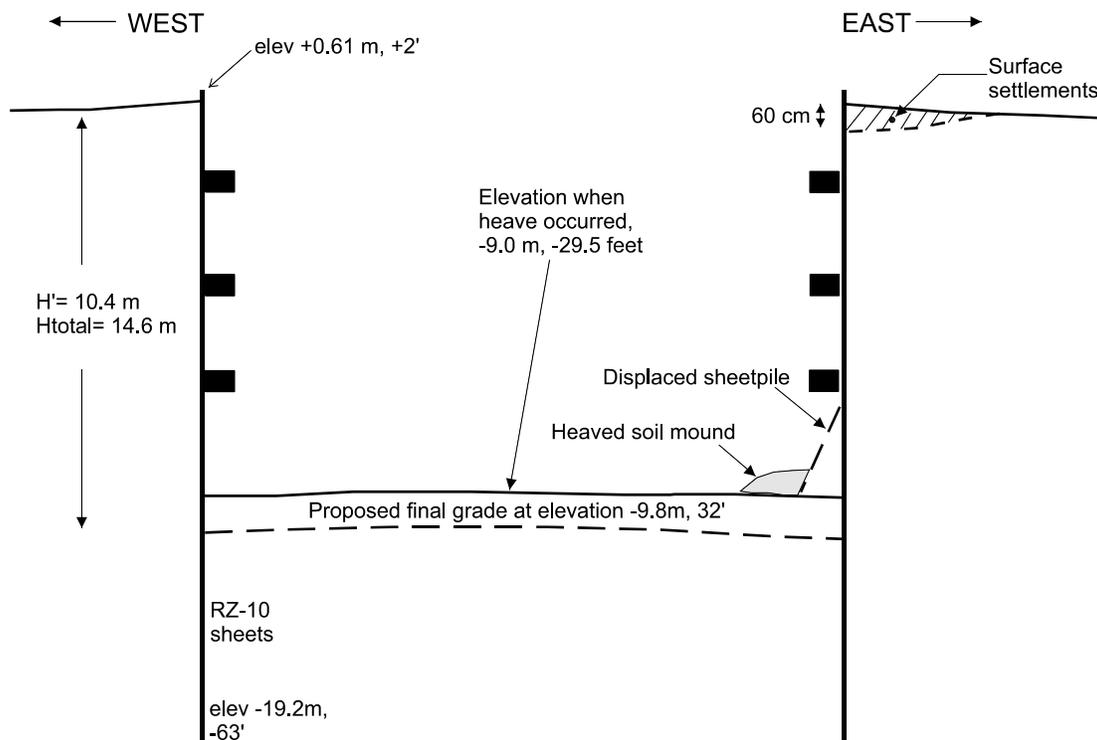
Figure 2. Cross-section of the Circular Cofferdam

Substantial inward movements of the second set of sheetpiles occurred at a location just below the third ring, after excavation to elevation -9.0 meters (-29.5 ft) in preparation for construction of the fourth ring. These movements occurred over a weekend. The east side of the cofferdam appeared to have been lifted as the sheetpiles moved inward, hinging about the bottom of the third ring. At this level, it was evident that the sheets had moved inwards at least 1.5 meters (5 ft) and were inclined roughly 2V:1H. The area behind the zone of movements had settled on the order of 60 centimeters (see Figure 2). It was also apparent that the top of the sheets in this area was lower than when originally driven. In addition, some settlements of the concrete compression rings had occurred towards this area.

Thereafter, the excavation bottom at -9.0 meters (-29.5 ft) was backfilled by the contractor to elevation -7.6 meters (-25 ft). Nevertheless, movements of the rings and the sheetpiles continued for several days. These movements consisted of settlements of the rings and tops of sheetpiles (about 13 centimeters), and separation of the uppermost lengths of sheetpile from the first ring (particularly at the east side), as if they were tilting away from the compression ring

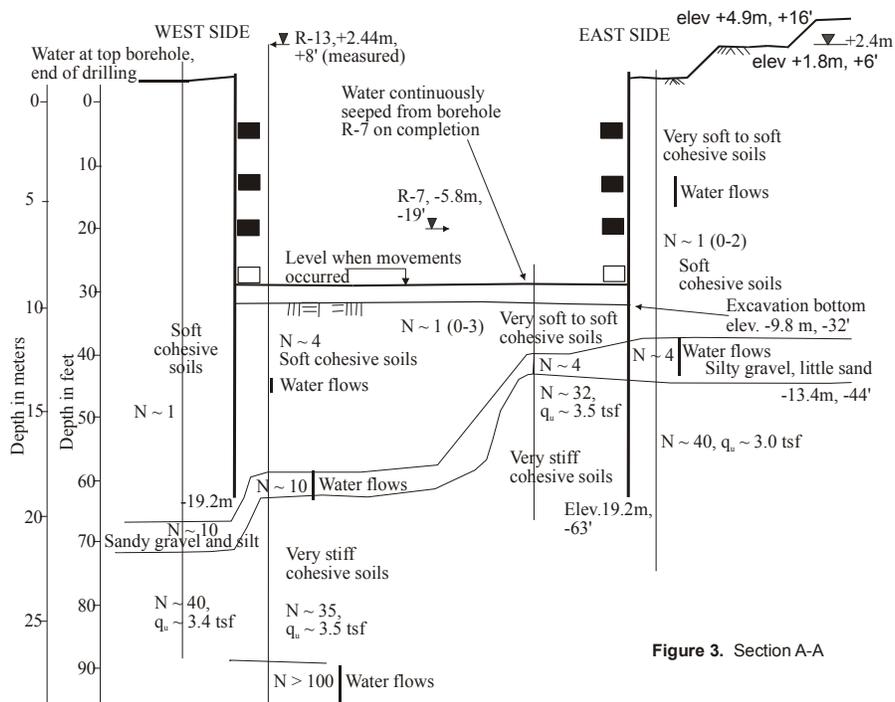
Figure 3. Section A-A

Borings were advanced using continuous sampling behind the area where movements occurred outside the circular cofferdam at the east side. The borings showed soft cohesive soils ($s_u \sim 10$ to 40 kPa, 0.1 to 0.4 tsf) to approximate depths of 11.4 meters (37.5 ft) below elevation $+0.61$ meters ($+2$ ft), with a 60 -centimeter layer of fine sandy silt below. Thereupon, a 1.2 -meter-thick layer of clayey silt and black peat of medium consistency was found. Past depths of 12.8 meters (42 ft), there were cohesive soils of stiff to very stiff consistency ($s_u \sim 200$ to 300 kPa, 2.0 to 3.0 tsf). Water flowing under pressure was found in the borings at depths of 11.9 meters (39 ft) and 15.9 meters (52 ft), and piezometers and observation wells were installed.

During both construction designs (the first and second cofferdams), it had been assumed that the underlying strata were continuous and that the various strata were uniformly distributed. The foundation design before the bid had been based mainly on two nearby borings; these boreholes were drilled using 1.5 -meter ($5'$) sampling intervals. The borings drilled after the movements occurred, within the affected zone, showed that the sheetpiles were embedded in hard soils; a cause for these movements was not readily apparent. Thus, a boring was drilled at the northwest periphery where no movements had been recorded. This boring presented a different layering sequence. Soft soils were found to elevation -18.6 meters (-60.9 ft) and the tip of the sheetpiles was shown to be barely into a medium silty clay layer. Beneath this layer and below the sheetpile tips, there was a 1.5 -meter-thick (5 ft) layer of sandy gravel and silt down to elevation -20.9

meters (-68.4 ft), followed by the very stiff silty clays also found in other borings. Surprisingly, the bottom of the sheets was not seated into the underlying hard clays, as indicated on Figure 3, West Side.

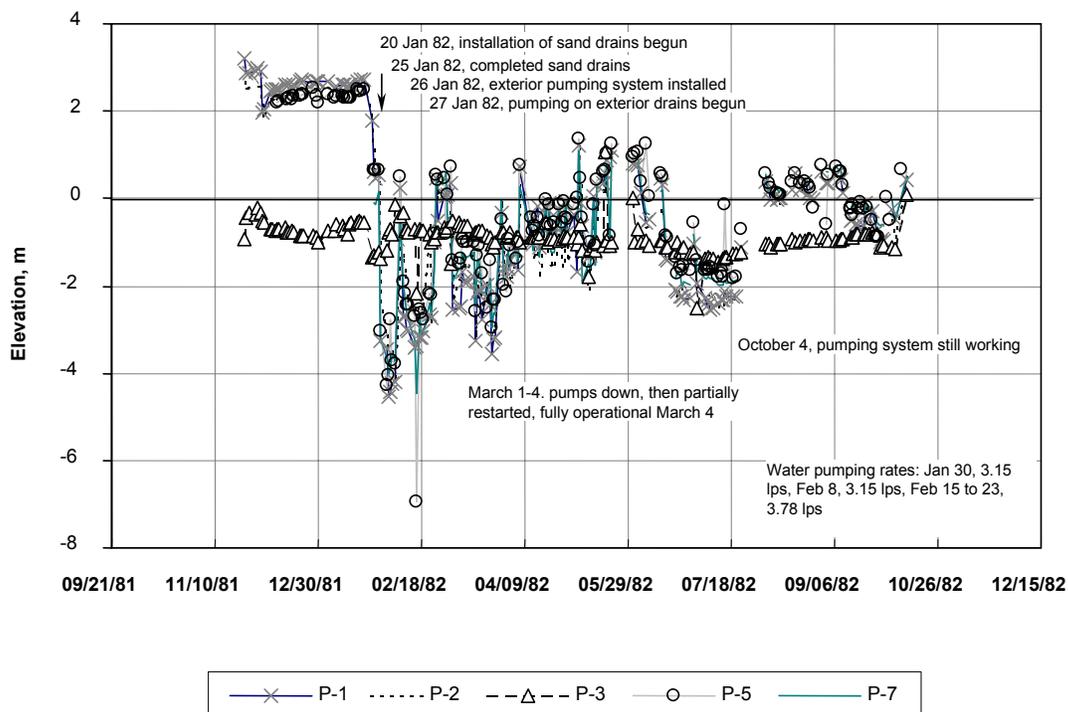
Figure 4. Piezometers Inside Circular Cofferdam

Seven (7) piezometers and one (1) observation well were installed. Interior relief wells or drains were installed inside the excavation. The interior water levels were near elevation -5.8 meters (-19 ft). Figure 4 is a graph of water pressures from the date of the failure until shutdown towards the completion of foundation construction for this structure. The interior sand drains were passive relief wells, 15 cm (6 in) holes drilled to depths of 11.3 meters (35 ft) inside the east side of the excavation and filled with sand and gravel, with 2-inch-diameter (5 cm) PVC casings, at typical spacings of 4.5 meters. Water flowed from these drains and was collected in sumps, as water levels inside the cofferdam decreased.

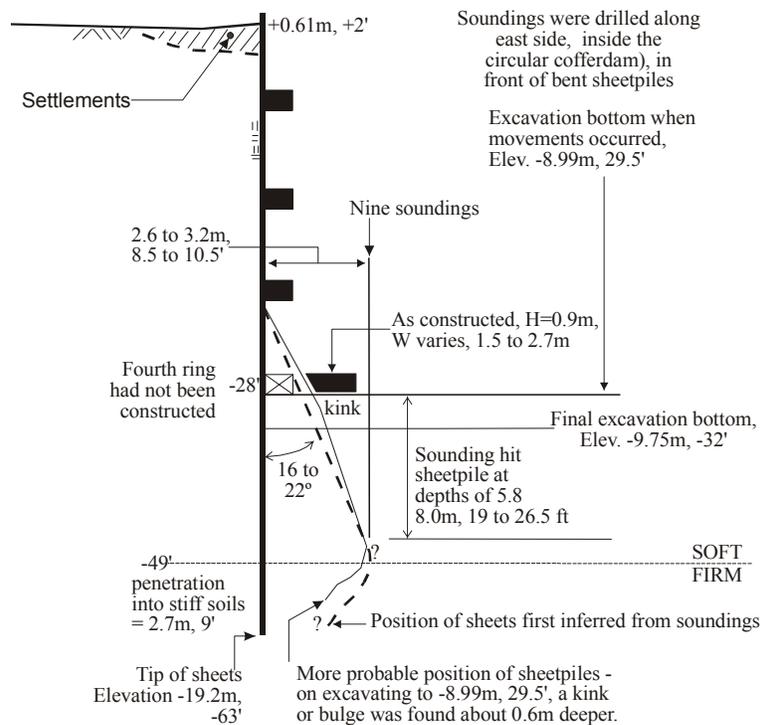
Figure 5. Displaced Sheetpiles, According to Soundings

After failure of the first (rectangular) excavation, it appeared that the easternmost wall moved inwards laterally as the interior bracing failed. When these sheetpiles were later removed, it became apparent that most of these sheets were bent twice along their length, first a kink indicating relative movement of the upper part into the excavation, then a reverse kink showing resistance opposite the direction of movement, as if the sheets at the tips were held back or restrained.

Soundings drilled within the second (circular) cofferdam confirmed that the tips of the sheets moved inward; the soundings were drilled until metal was encountered. The soundings indicated lateral inward movements, as shown on Figure 5. Much later, after excavating for the fourth ring, it was shown that the sheets had a kink or bulge about 60 centimeters below the bottom of the excavation at the moment when movements occurred. This kink was in the reverse direction from the inward movements. The inverse direction of the kink indicates that the tip of the sheetpile piles

With the subsoil information obtained, it was concluded that the movements were caused by uplift of the inner soils lying above the granular layer. The movements occurred after uplift of the inner soils, causing loss of interior support to a substantial length of the sheetpile. The exterior forces would continue to act; the sheetpile would have to move inward due to its inability to resist such excessive unbalanced forces. Bending of the sheetpile would begin to occur somewhere below the third ring. Further below, the sheetpile tip was in hard clay. Eventually, the sheetpile would move, either by rotational displacement of the tip or by being pulled from its clay socket. The presence of the kink or bulge previously mentioned (Figure 5) confirms that movements occurred in this sequence, after the bottom soil was uplifted.

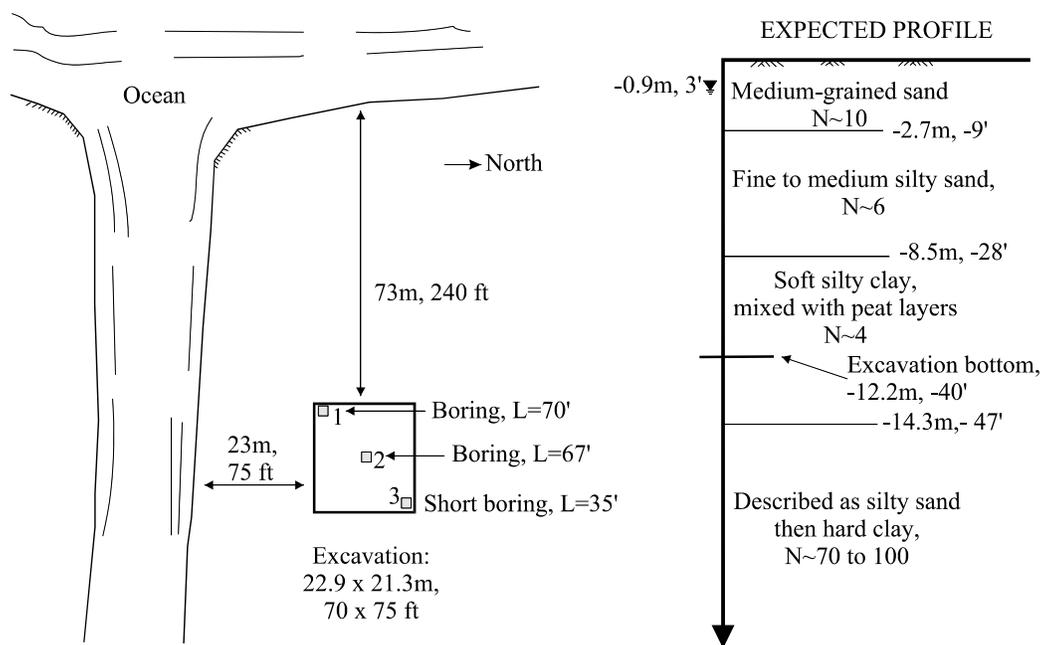
Figure 6. Location and Expected General Profile

The excavated area was to be 22.9 by 21.3 meters (75 x 70 ft). The pump station was sited 73 meters from the ocean and 23 meters from a small river on another side. Three borings had been drilled during design on a diagonal line across the proposed structure, as shown on Figure 6; they showed loose silty sands to depths of 12 meters with interlaying soft soils, including a 1.5-meter layer of peat. On award of the bid and based on the design borings, the contractor had purchased 18.3-meter (60 ft) sheetpile sections (Larssen II-S, 70 kg/m). They were initially driven with a vibratory hammer (LB Foster 275E).

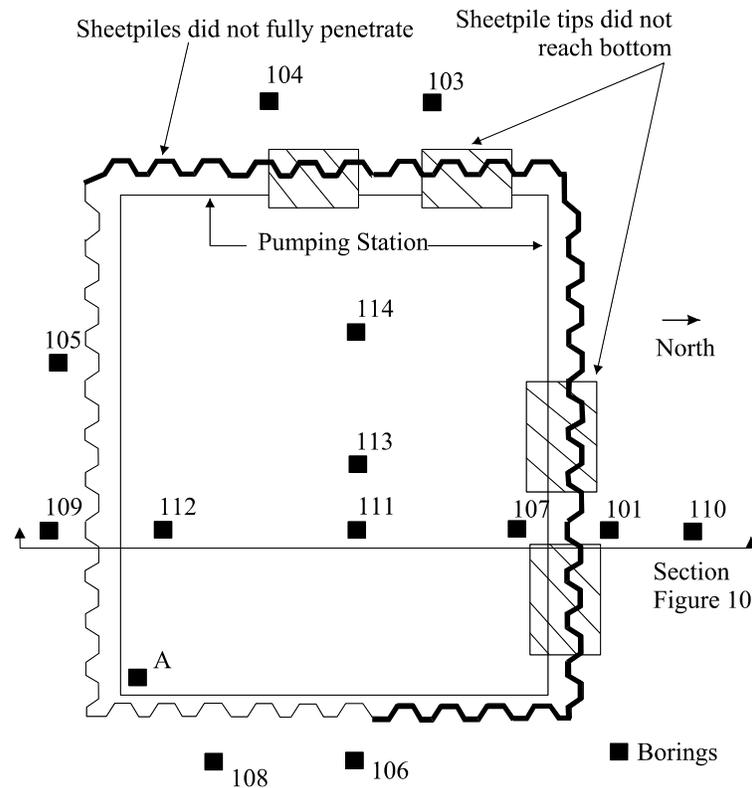
Figure 7. Sheetpile excavation

sides of the excavation the sheets did not penetrate fully and in some instances did not even reach the bottom of the excavation. The piles were redriven using a Link Belt 520 hammer (35.9 kN.m or 26,500 ft-pounds) but additional penetration was minimal, never exceeding 1.5 meters. One of the sheets was pulled and showed excessive damage at the tip. However, at other areas (east and south) the piles were easily inserted and reached the 18.3-meter depths using the same vibratory hammer (see Figure 7). The shallow sheetpile penetrations were unexpected and particularly worrisome, since lack of embedment below the excavation bottom could lead to instability.

Thick sheetpile line indicates areas where sheetpiles did not fully penetrate.
Hatched zones indicate areas where sheetpile did even not reach excavation bottom.

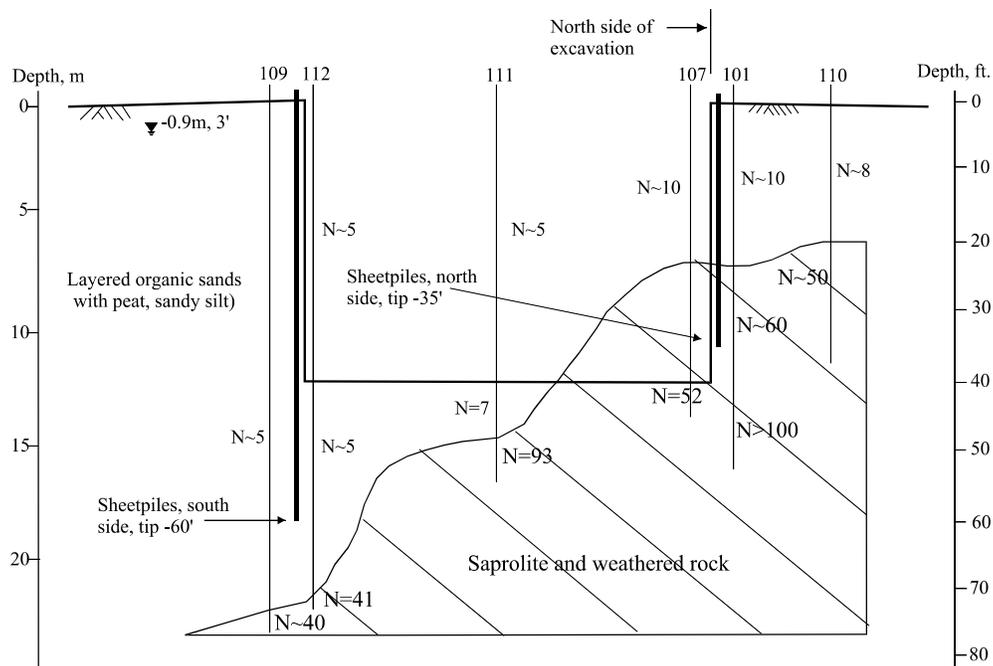
Figure 8. Actual Subsoil Profile

Additional borings were drilled along the sides of the excavation. Figure 8 shows the subsoil profile obtained after the last investigation. The saprolitic material from weathered volcanics clearly varied in depth throughout the site, from 9 meters on one side to 22 meters on the other. Clearly, one side of the excavation would enter the saprolite or weathered rock, whereas the other side of the excavation would still be in soft soils. To the north, the sheets could not penetrate to the excavation bottom, whereas to the south, the sheets sank their full length under a vibratory hammer.

Lateral pressures on each side of the excavation would vary and cause uneven displacements, given the variations in depths of soft and loose soils. Since there were no nearby structures, uneven displacements and surface settlements did not concern us. Stability of the excavation was another concern, as some of the sheets did not reach the excavation bottom (Figure 8). On inspection of the saprolite samples, it was observed that the weathered rock was massive and would perform as an impervious mass, similar to a clay soil, notwithstanding the fact that the samples, once recovered, behaved as friable silts. Water was not expected to flow freely through this soil which retains many characteristics of the parent rock. The short term strength of the saprolite was undoubtedly high; experience in these soils indicates that the undrained cohesive strength is not lost with time or is available for a long time, possibly due to cementation.

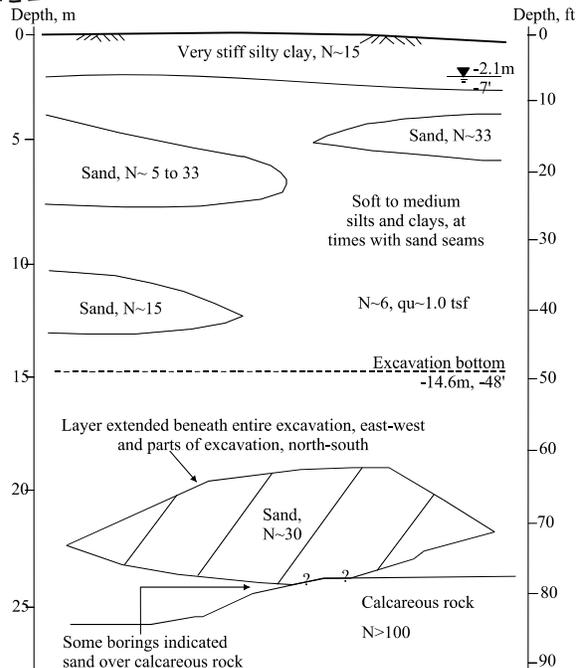
Figure 10. Subsoil Profile

borings also revealed the presence of a layer of clean medium to coarse sand within the stiff clay, as shown in Figure 10.

Piezometers did not indicate pressures which greatly exceeded the general phreatic surface. However, the presence of a trapped aquifer was cause for concern as the excavation bottom would lie near the sand layer. Since sheetpiles could not penetrate the hard clay layer to seal against water flows, water pressures could blow the excavation bottom, as the weight of the soil plug was less than the probable water pressures (shown on Figure 11). While the sand layer did not extend over the entire area, the pressures were sufficiently unbalanced so that blowup was cause for concern.

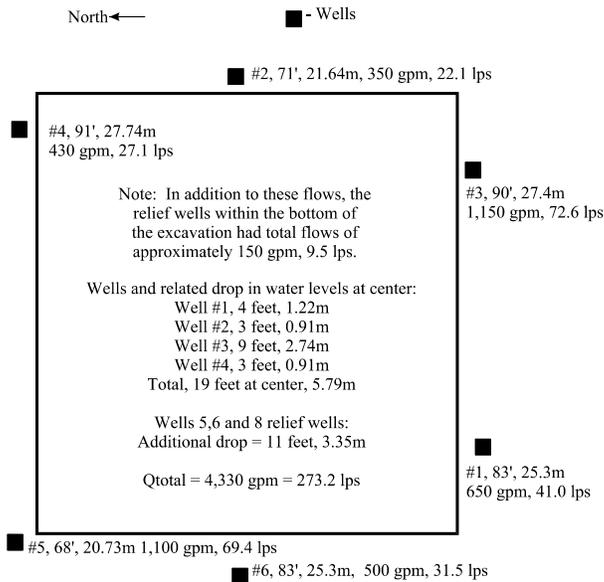
Figure 12. Wells and Pumping Rates

than the width of any soil plug. Assuming a confined layer, it was calculated that pumping 88 lps (1,400 gpm) would be required for reduction of the water pressure by 8.5 m (28 ft), so that the soil weight was the same as the uplift pressure. Four deep wells were installed as shown on Figure 12 but were not overly effective. The construction of the wells was highly suspect, due to inappropriate well screens with low entrance areas and doubts regarding installation of the well gravel packs, particularly their location with respect to the pervious layers and their thickness. Erroneous permeabilities could also

have been obtained from an initial pumping test on the first deep well, or the sands and calcareous soils below could be interconnected. Nonetheless, in spite of the wells, piezometers in the center of the excavation showed that drawdown was only 5.8 m (19 ft) whereas 8.5 m (28 ft) were required to avoid blowup.

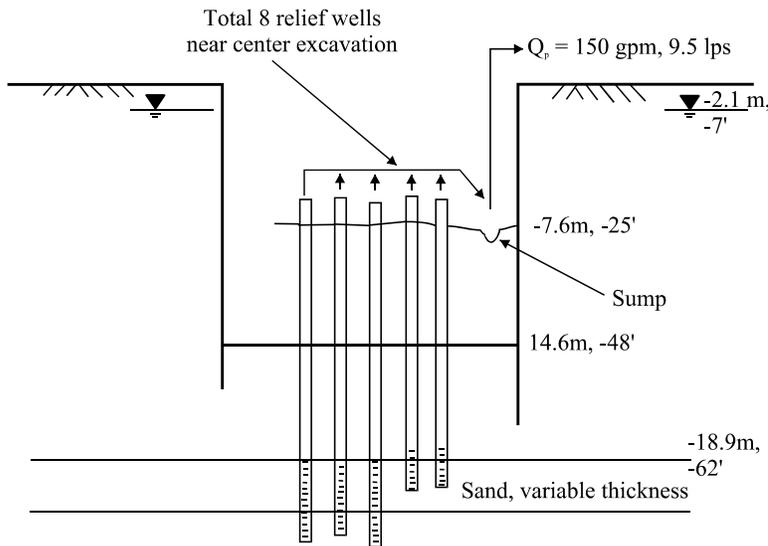
Figure 13. Relief Wells Within Excavation

Wells(8) installed on reaching -25 ft, -7.6m. The water sump was moved as excavation proceeded. Wells were passive wells and water flowed without pumps from pipes and onto ground through gravel working mats to sumps.

a series of passive relief wells within the excavation bottom, taking these wells to a sump (Figure 13) with two additional exterior deep wells (#5 and #6). The pressure then dropped below the required levels (to -9.1m, -30 ft) and the excavation was completed. Pressure relief was immediate as the passive wells were installed, since they were located in what is undoubtedly the most effective location, near the excavation center.
