Influence of Subsurface Details on
Braced Excavations in Puerto Rico
Alan R. Crumley, F. ASCE ¹

This is a condensed version of a paper presented at the ASCE National Convention in October, 1998 at Boston.

Case History I - A Deep Excavation Affected by Blowup

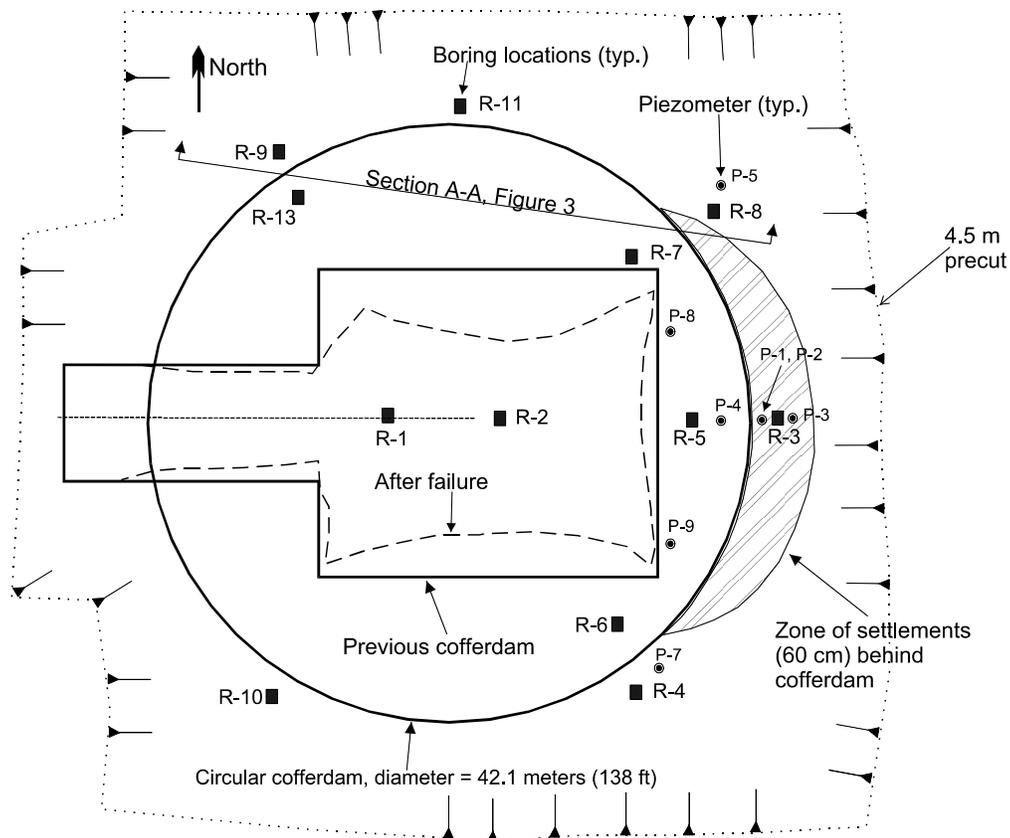
Figure 1. Plan View

A rectangular braced cofferdam had failed in the initial stages of construction and had been substituted by a circular cofferdam with a new designer. The first set of sheetpiles had been cut at various levels and left in place, being cut as necessary as the second excavation progressed. The second cofferdam encircled the outline of the first cofferdam and most of the pumping station that was under construction, as shown in Figure 1. This second cofferdam consisted of 65-foot-long (19.8 m) interlocking sheetpiles driven from elevation 0.61 meters (+2 ft), with four (4) circular reinforced concrete rings acting as interior supports; the rings were 1.5 m wide by 0.9 m high (5 x 3 ft). The required bottom of the excavation was elevation -9.76 meters (-32 ft).

Substantial inward movements of the second set of sheetpiles occurred at a location just below the third ring, after excavation to elevation -9.0 meters (-29.5 ft) in preparation for construction of the fourth ring. These movements occurred over a weekend. The east side of the cofferdam appeared to have been lifted as the sheetpiles moved inward, hinging about the bottom of the third ring. At this level, it was evident that the sheets had moved inwards at least 1.5 meters (5 ft) and were inclined roughly 2V:1H. The area behind the zone of movements had settled on the order of 60 centimeters (see Figure 2). It was also apparent that the top of the sheets in this area was lower than when originally driven. In addition, some settlements of the concrete compression rings had occurred towards this area.

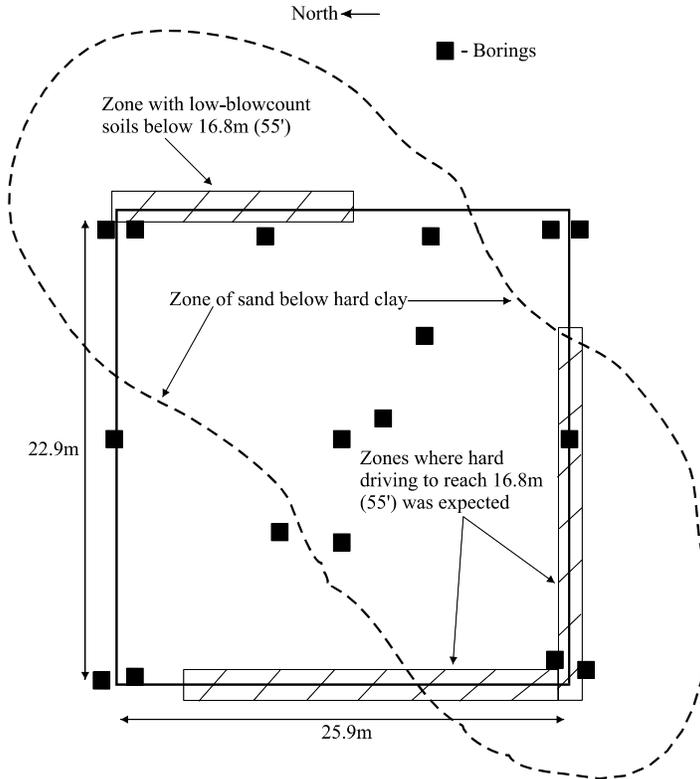
Figure 9. Plan View

A pumping station was to be constructed, with the excavation sized at 22.9 by 25.9 meters (Figure 9). The excavation depth was 14.6 meters (48 ft) and water was found at a depth of 2.1m (7 ft). Six borings were drilled during design using standard 5-foot (1.5-meter) sampling intervals. They revealed soft soils overlying a calcareous basement, and did not penetrate deeply into the stiff materials. Borings drilled during the excavation design using continuous sampling showed soft soils to depths of 14.6 meters (48 ft) with several layers of sand. Below this depth, the soils consisted of stiff to hard clays, followed by the calcareous rocks. However, some of the

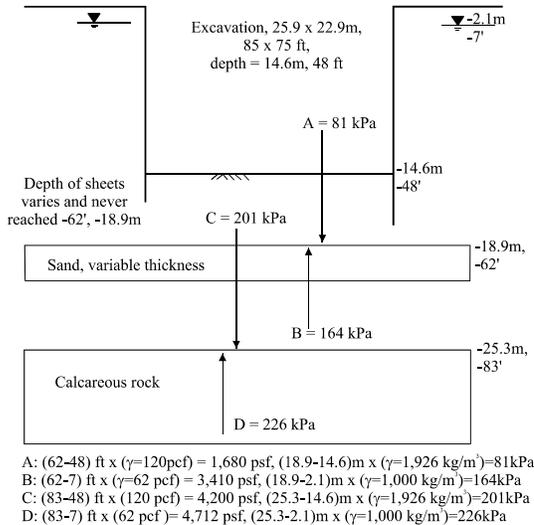
Figure 11. Blowup Formulation

Piezometers did not indicate pressures which greatly exceeded the general phreatic surface. However, the presence of a trapped aquifer was cause for concern as the excavation bottom would lie near the sand layer. Since sheetpiles could not penetrate the hard clay layer to seal against water flows, water pressures could blow the excavation bottom, as the weight of the soil plug was less than the probable water pressures (shown on Figure 11). While the sand layer did not extend over the entire area, the pressures were sufficiently unbalanced so that blowup was cause for concern.
